June 10, 2021

**PERIMETER FENCE REPAIRS MEMORANDUM  
KEYSTONE SANITATION LANDFILL SUPERFUND SITE  
UNION TOWNSHIP, ADAMS COUNTY, PENNSYLVANIA**

HydroGeoLogic, Inc. (HGL) is submitting this memorandum on behalf of Waste Management Disposal Services of Pennsylvania, Inc. (WMDSPI). This memorandum details the field activities to repair specific sections of the perimeter fence.

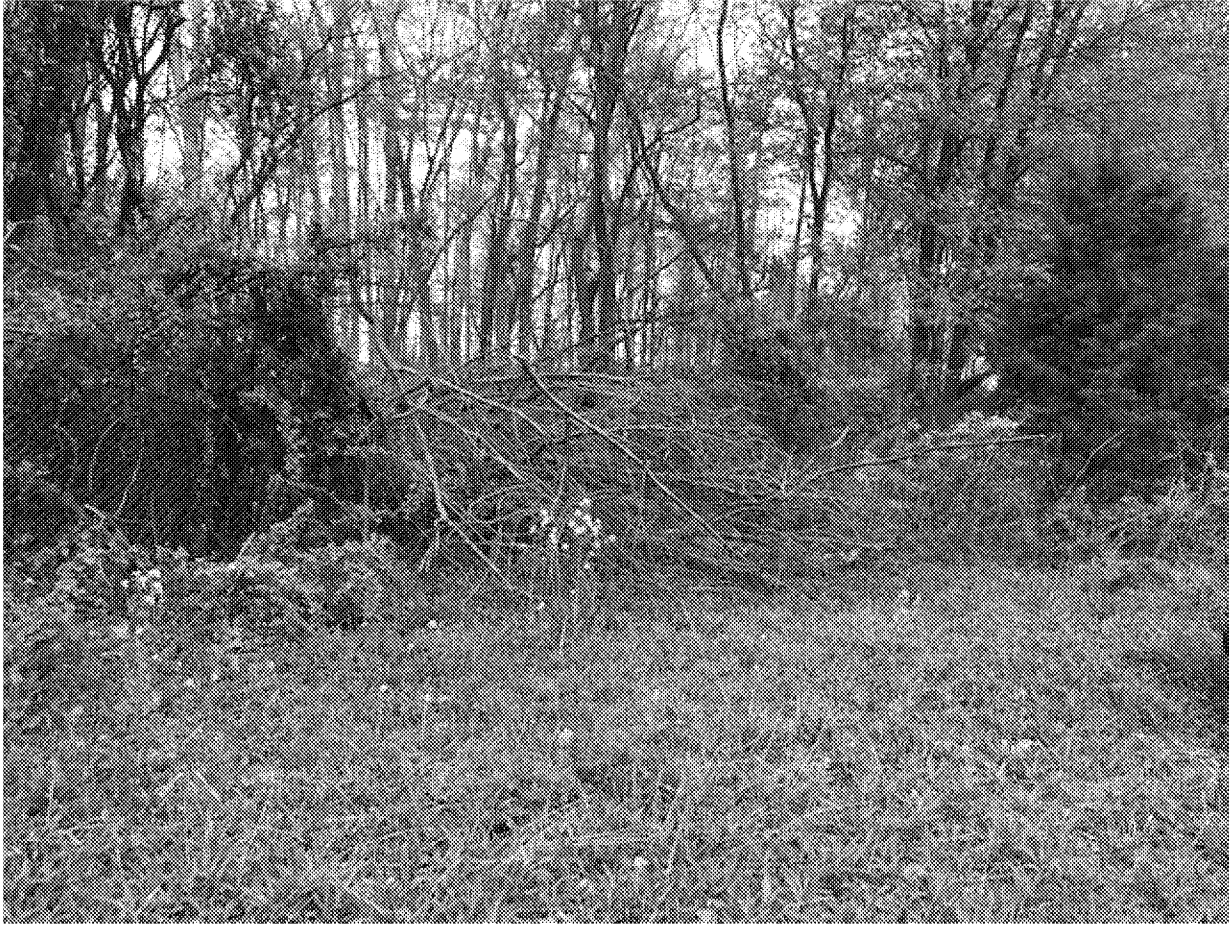
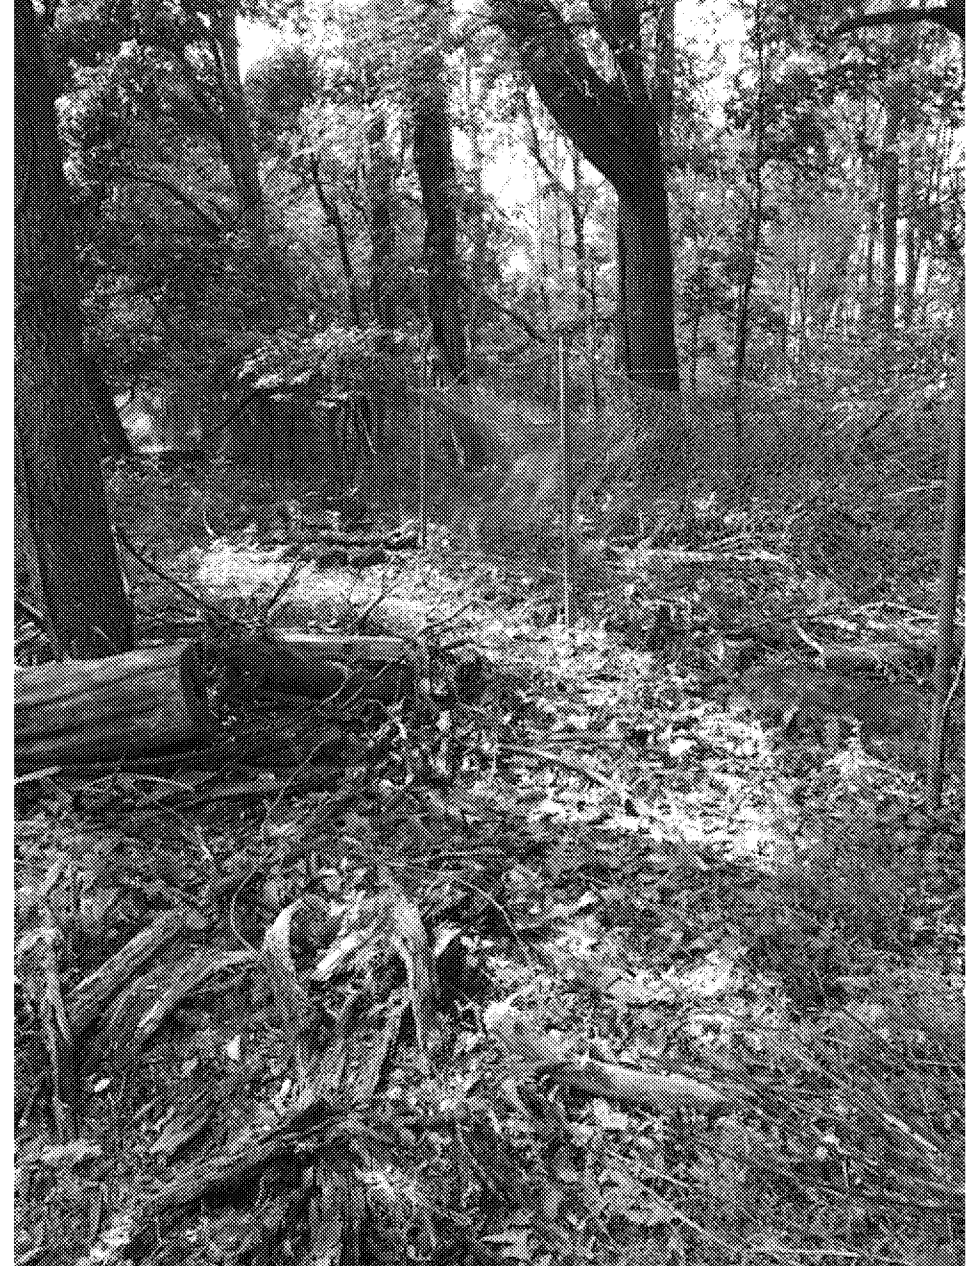
Picture 1: Twenty feet of fence down. Cleared brush off fence line. No significant structural damage to the fence.

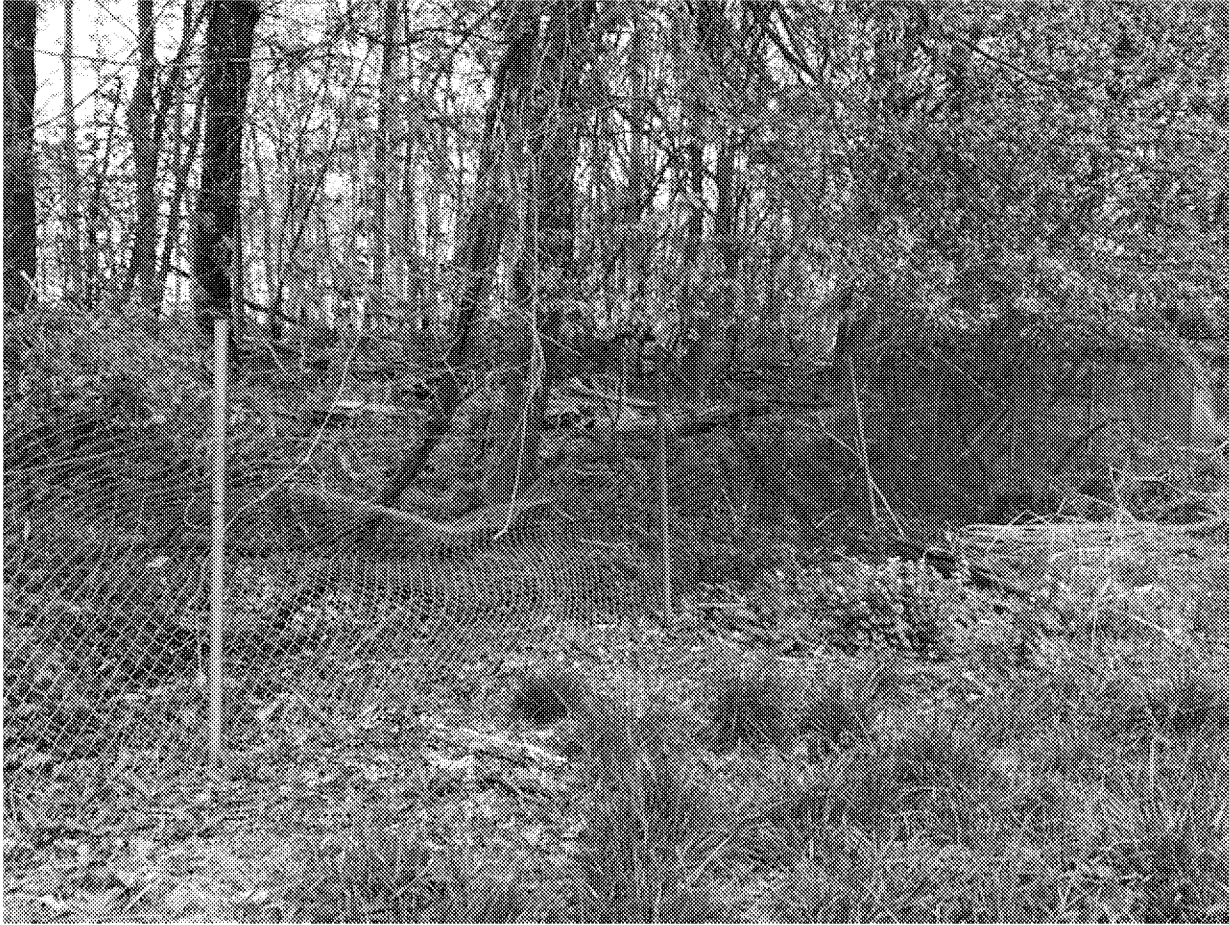
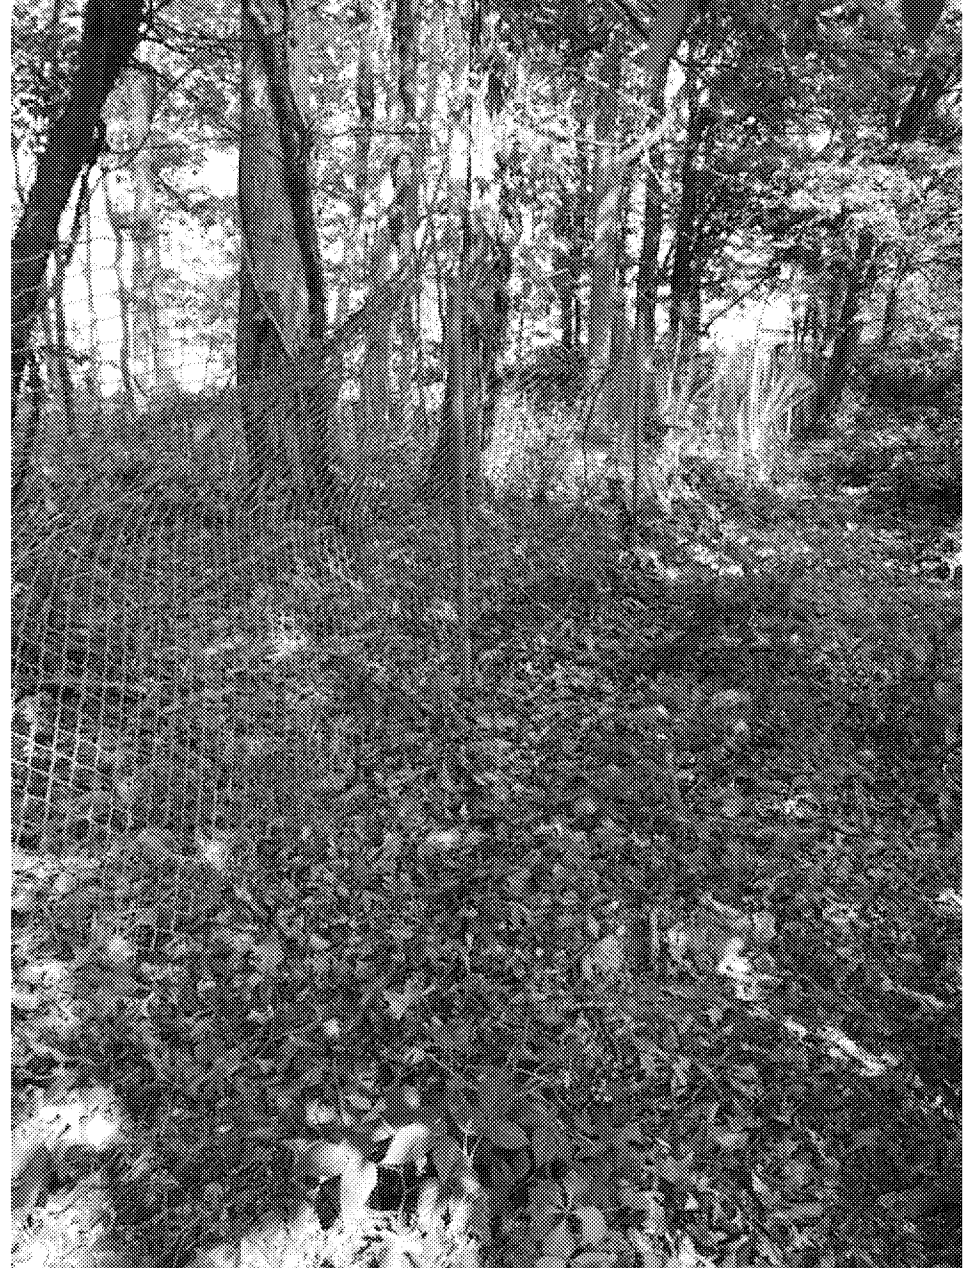
Picture 2: Approximately 10 feet of fence line was reattached to the poles and/or straighten out.

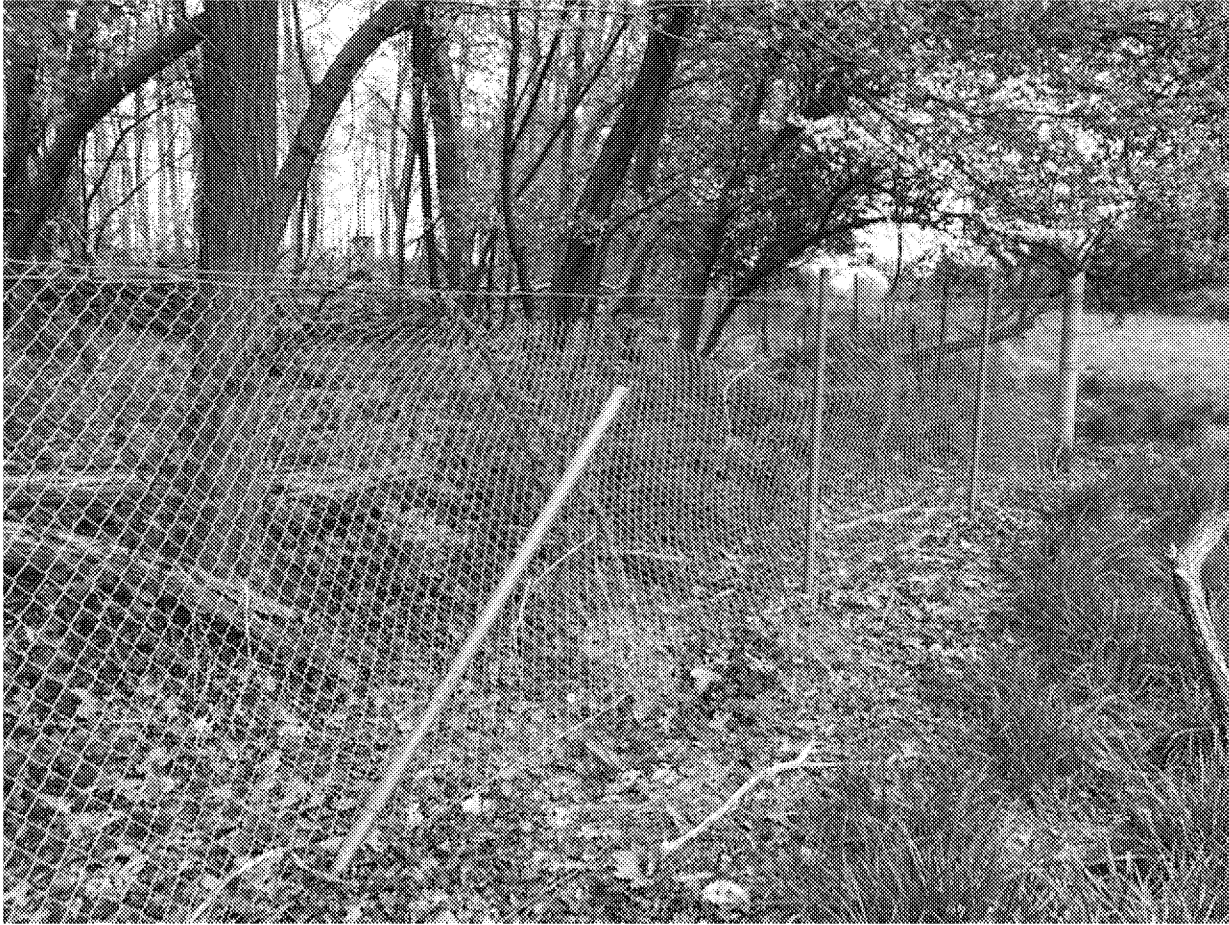
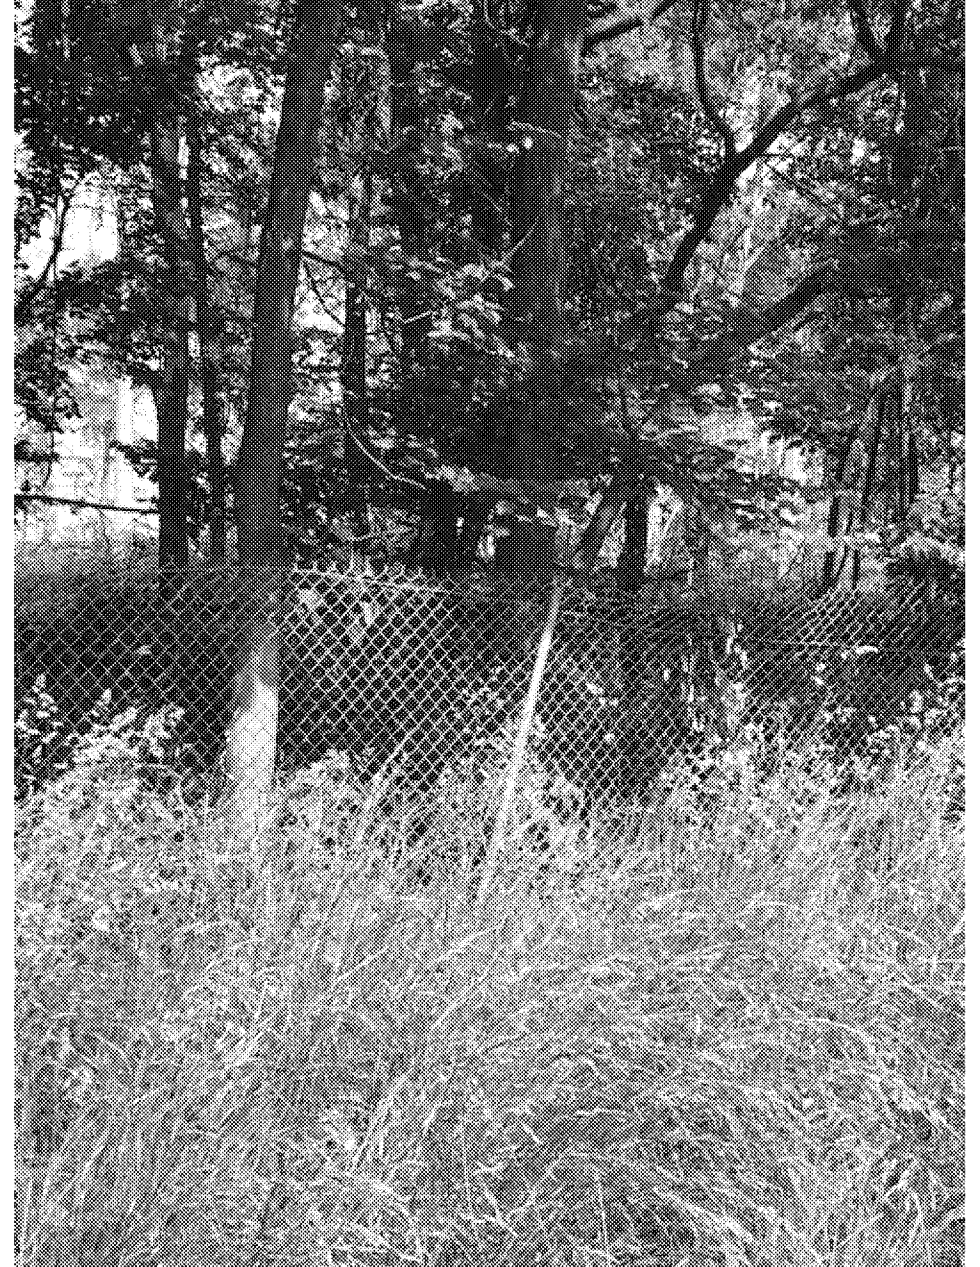
Picture 3: Five feet of fence was down, and the post was bent; both issues were fixed with existing materials.

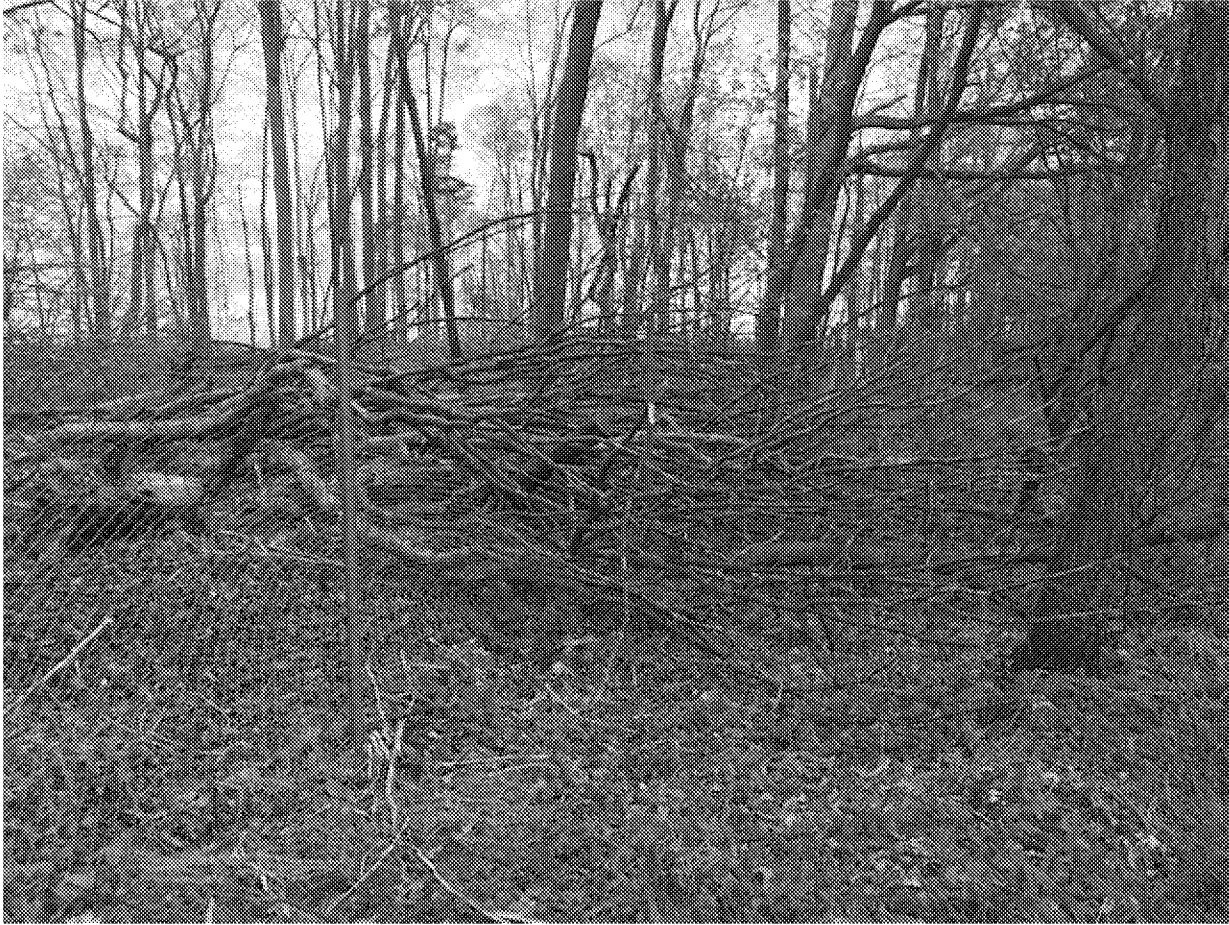
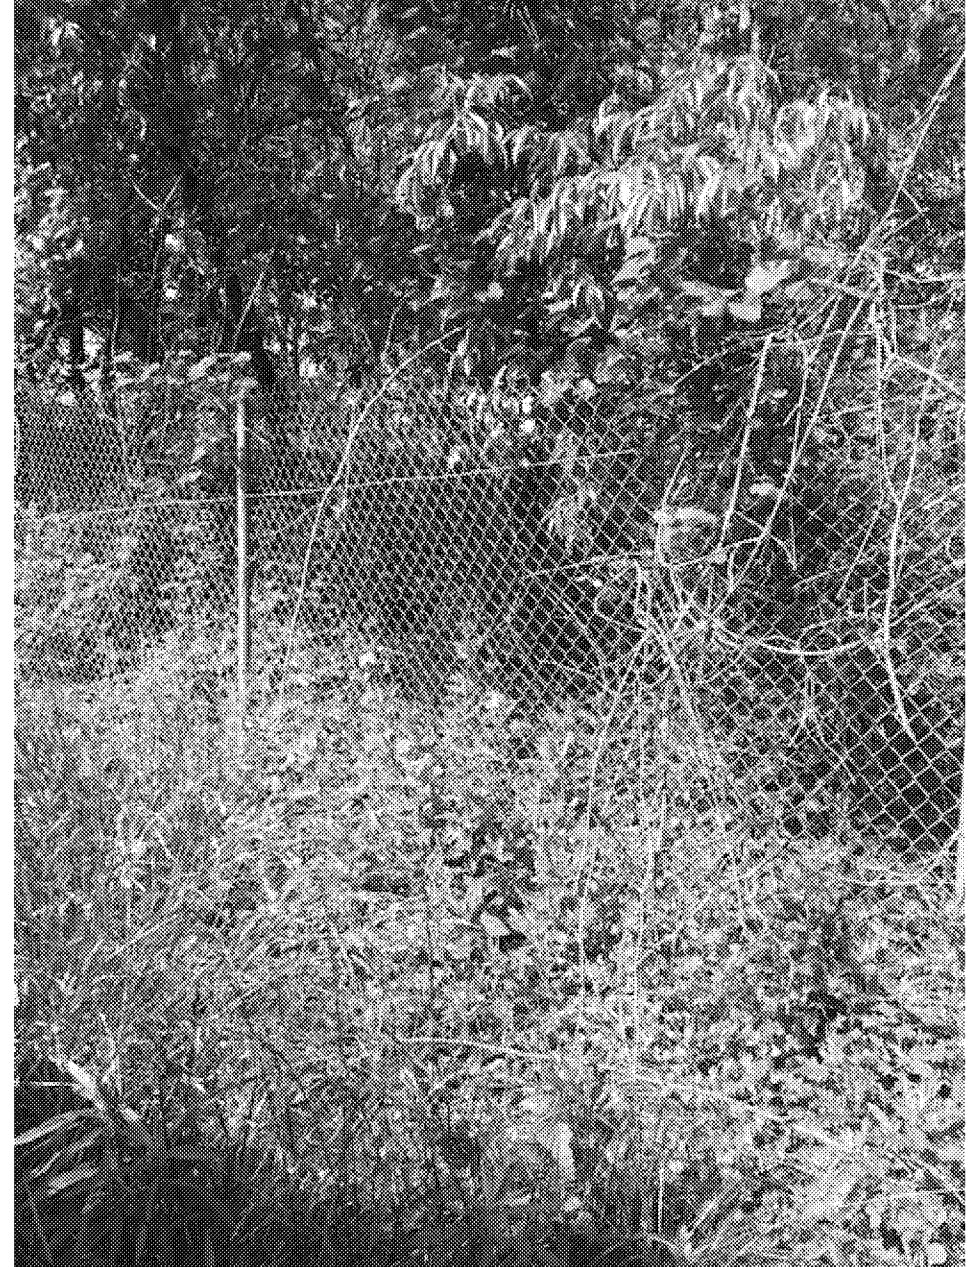
**Picture 4: Removed tree branches from a 10-foot fence section and cleared the brush to put back the fence.**

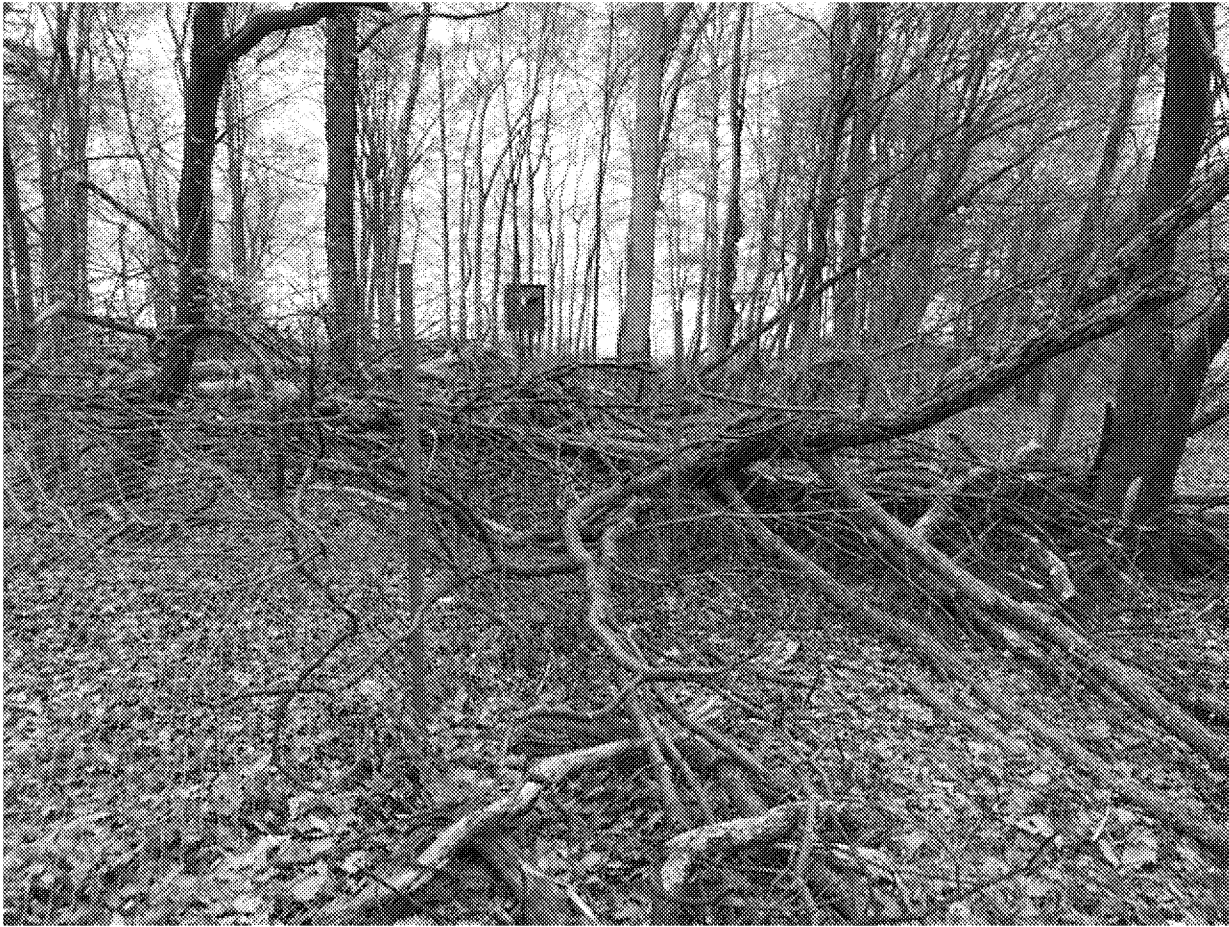
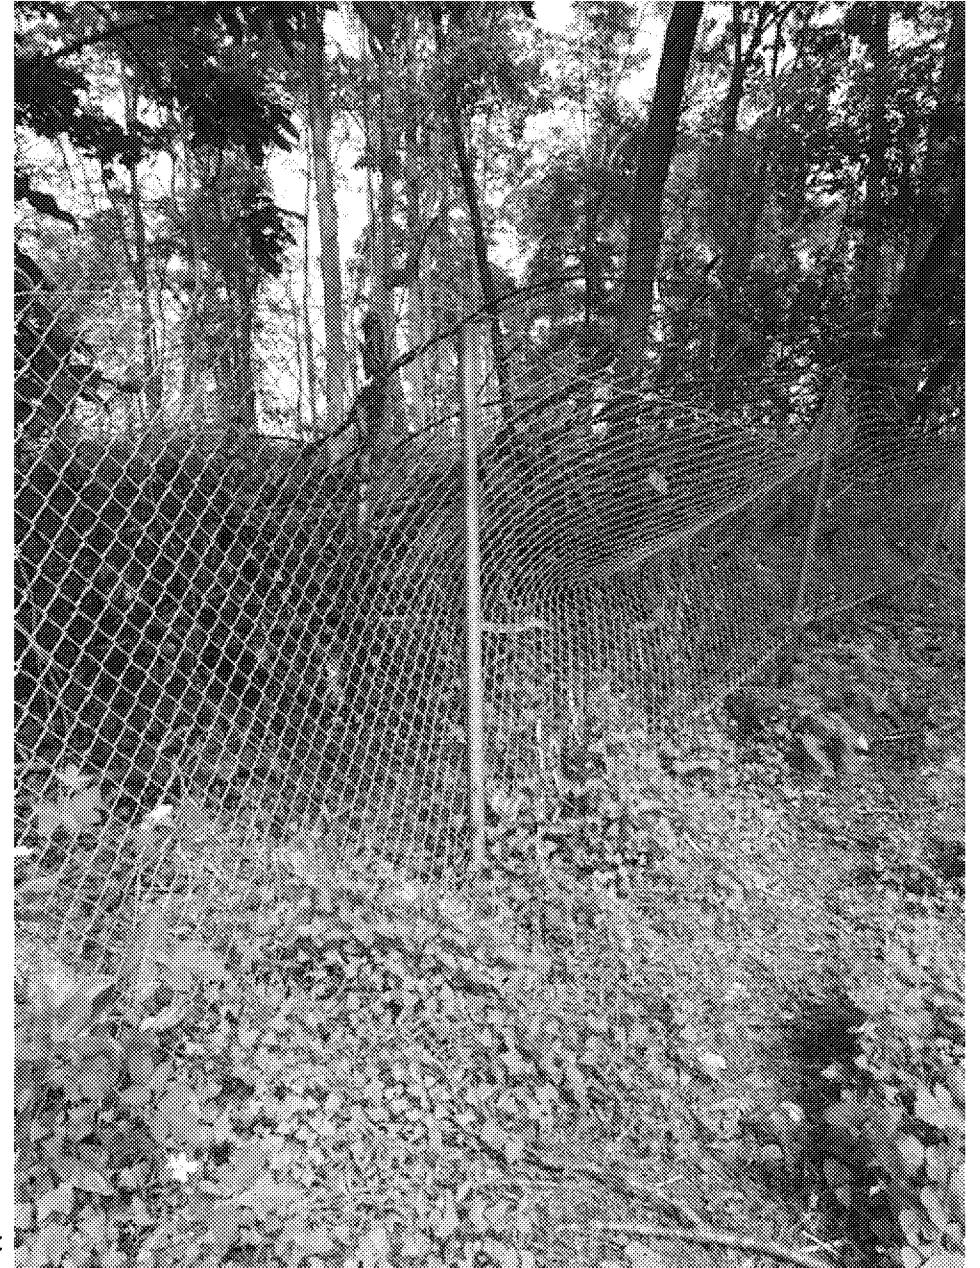
Picture 5: Twenty feet of fence was down due to multiple trees. Once branches were removed, the fence was put back on.

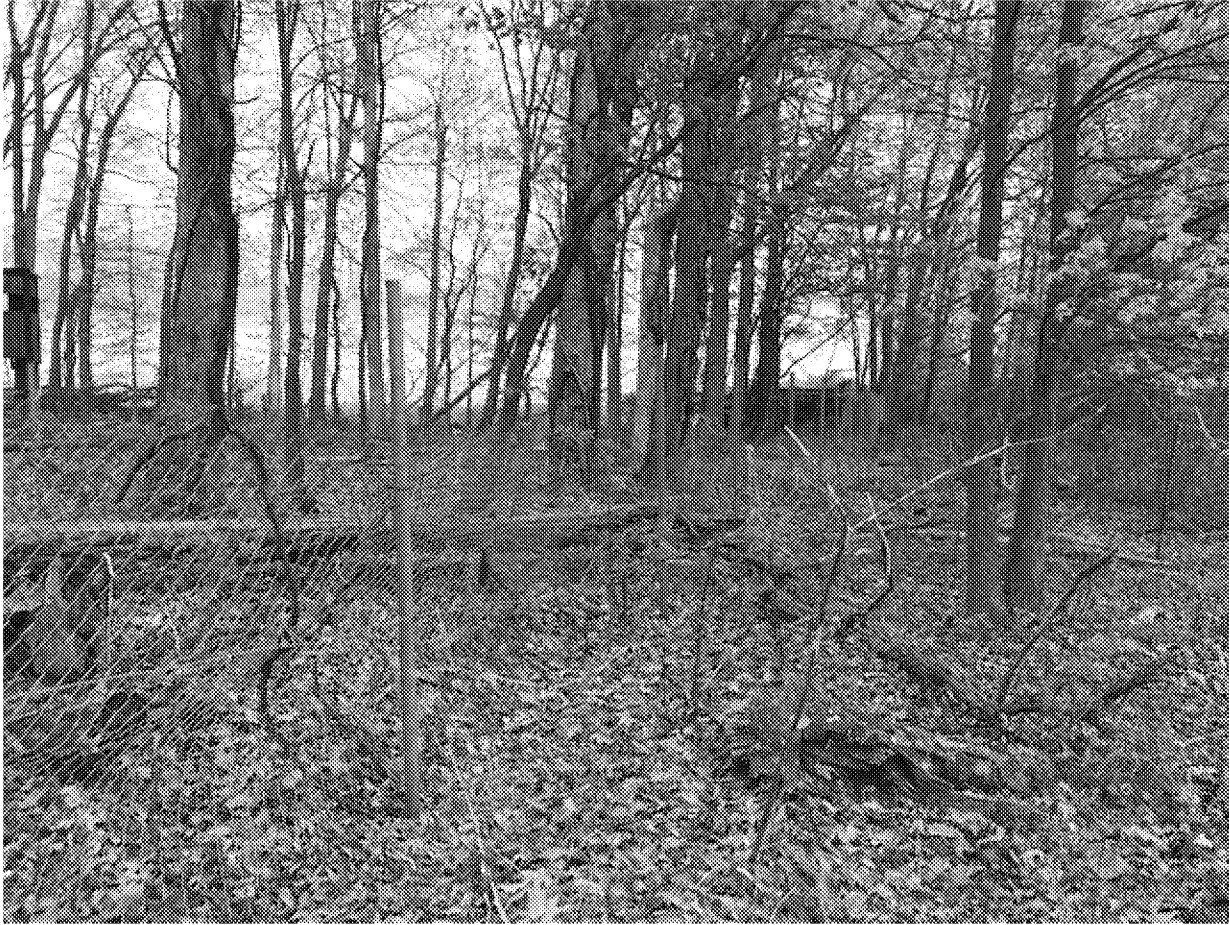
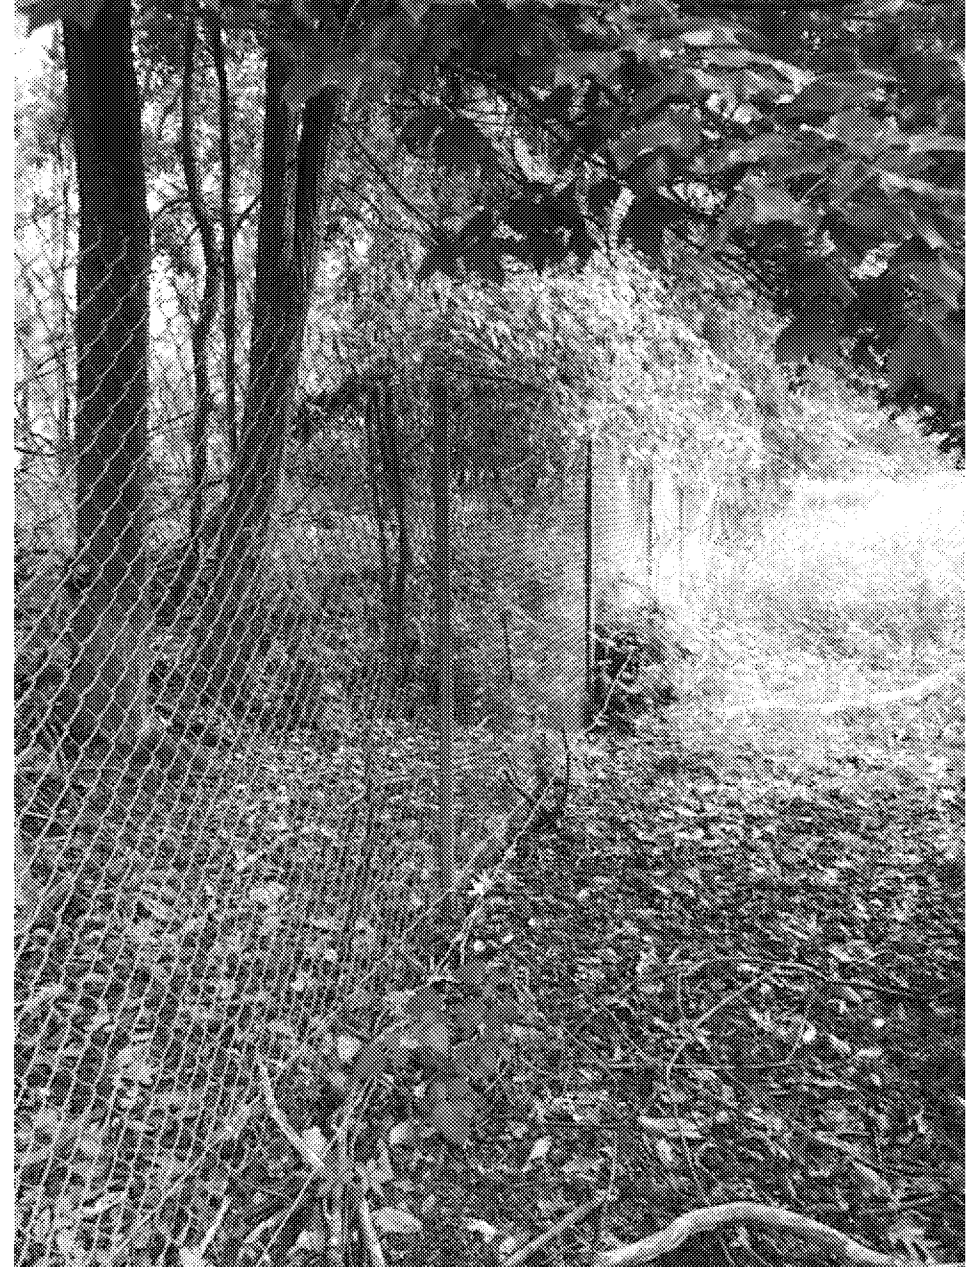
Picture 6: Fifty feet of fence was down. Cleared brush, removed trees, and put back fence on.
